## FRAME STAGE INSPECTION REPORT

1234 Main st.  
undefined, undefined undefined

Buyer Name  
06/06/2022 9:00AM

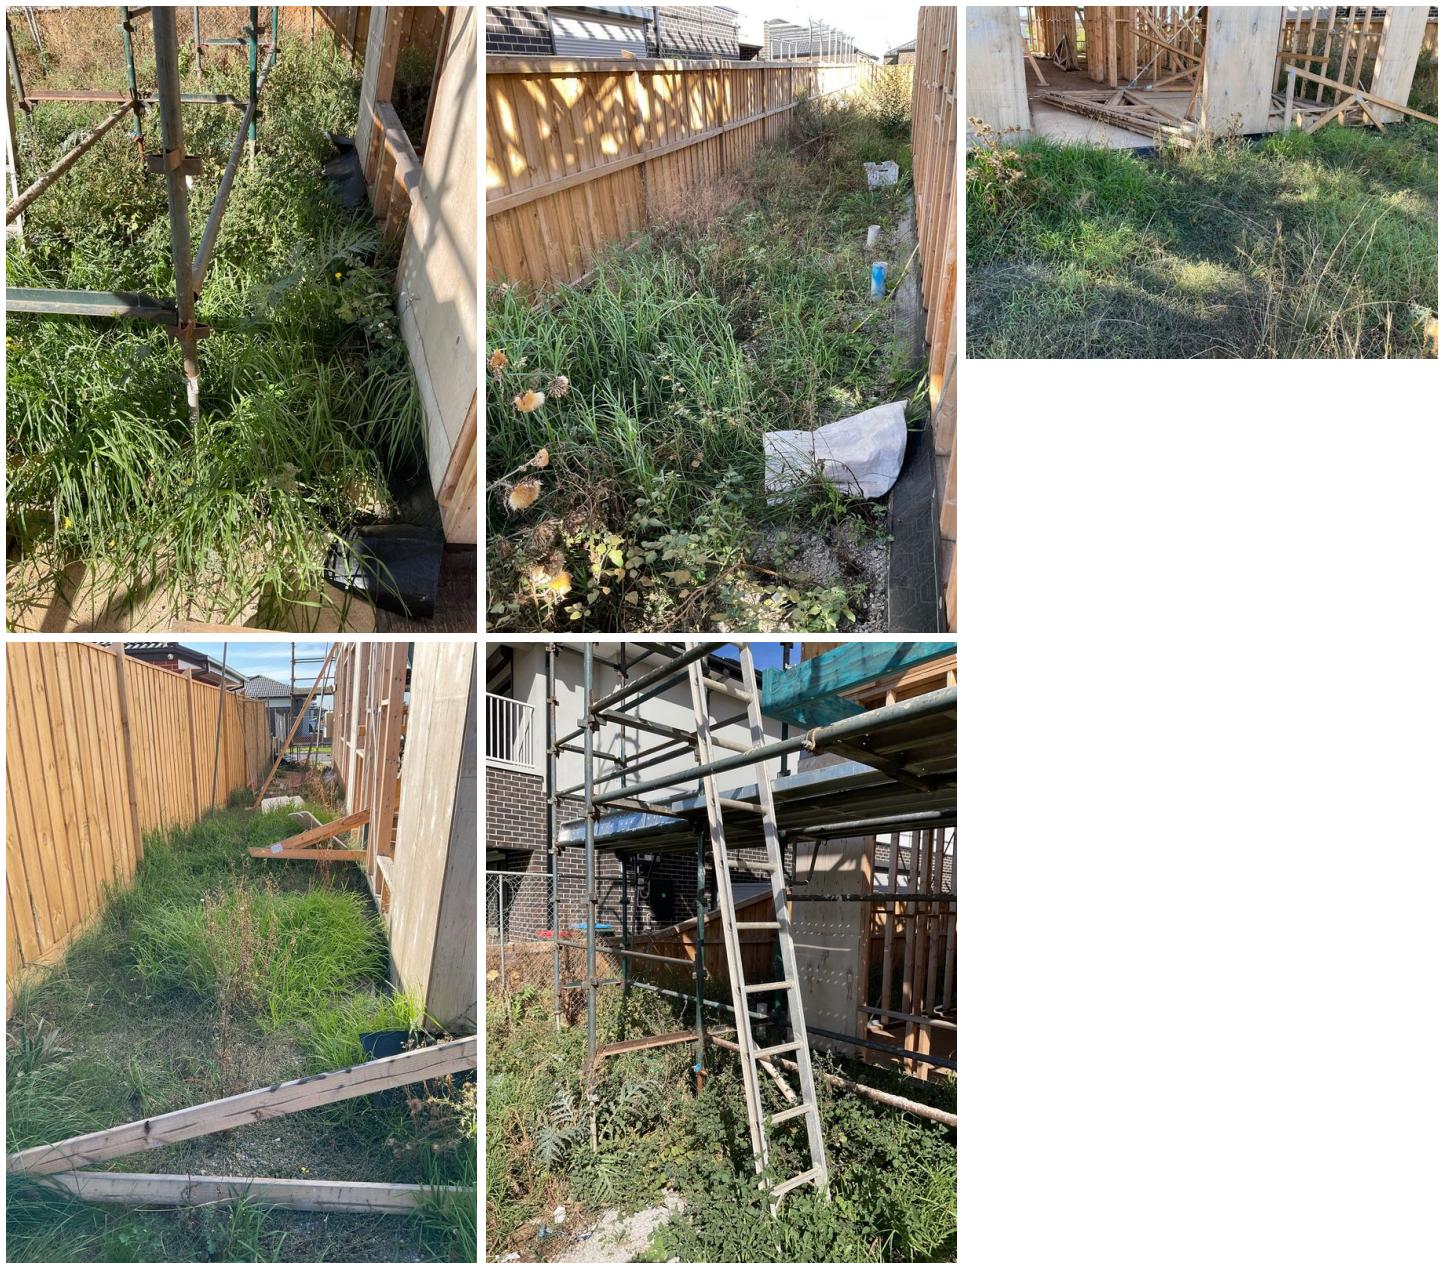
Vegetation., Scaffold safety compliance notice

Note. There is no notification to state that the scaffold is compliant and safe for site personnel.

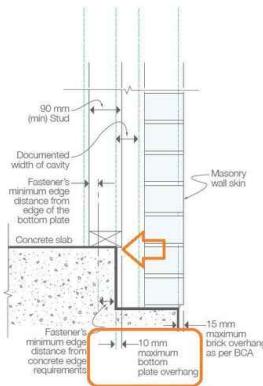
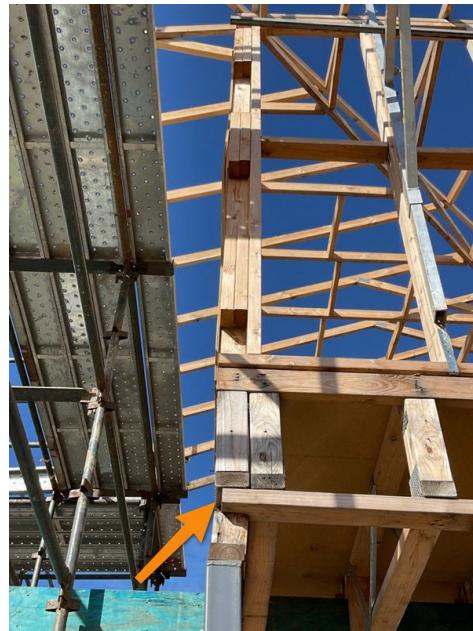
DIAGRAM 4.08 BOTTOM PLATES THAT OVERHANG CONCRETE SLABS

Bottom plates that are 90 mm wide or greater and overhang concrete slabs by more than 10 mm are defective.

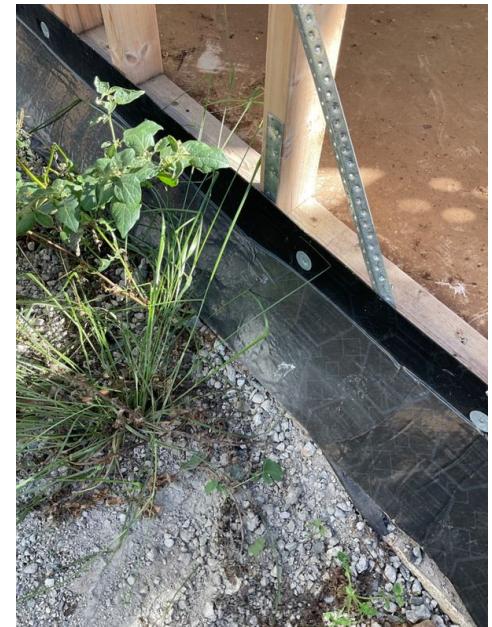
### 3.1.2 + House Edge Rebate + UNABLE TO INSPECT

Unable to inspect all sections of the slab edge due to installed termite physically barrier, dampproof membrane, or sarking/flashing.

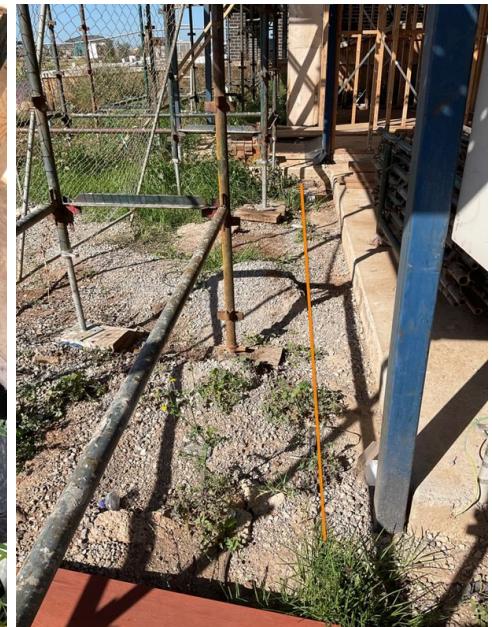
Figure 3.2.2.3 Acceptable vapour barrier and damp-proofing membrane location

#### + VAPOUR BARRIER NOT VISIBLE

The under-slab vapour barrier was not visible in all or few areas at the time of inspection. The vapour barrier must cover the bottom and side of the concrete slab and should be extended to pass the natural ground.

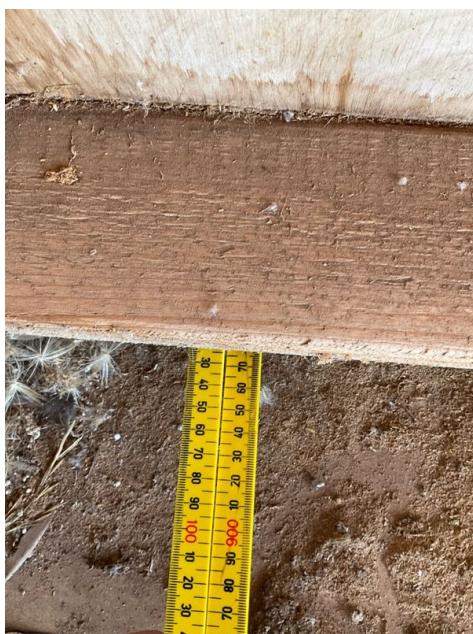
Garage Rear

#### Guide to Standards and Tolerances - 4.08

Bottom plates that are 90 mm wide or greater and overhang concrete slabs by more than 10 mm are defective.

The concrete needs to be trimmed so that the plasterboard can extend as required. Protect any exposed reinforcement.

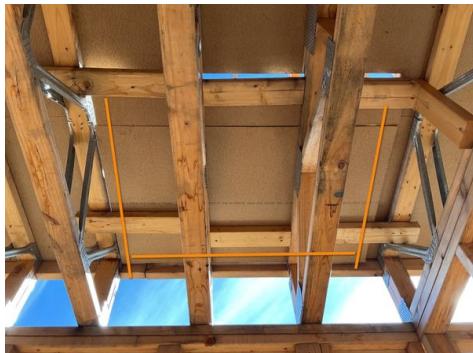
Ensuite 2

First floor. All shower step downs.

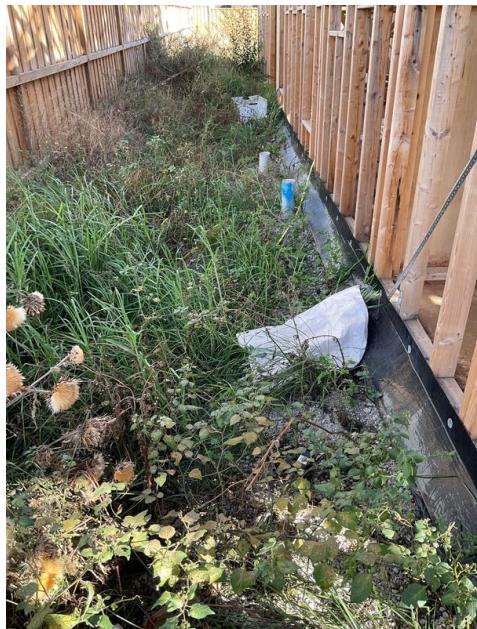
Rear

As per AS2870, crushed rock should not be used to backfill slab edge. Tampered, graded clay must be used to drain surface water away from the building.

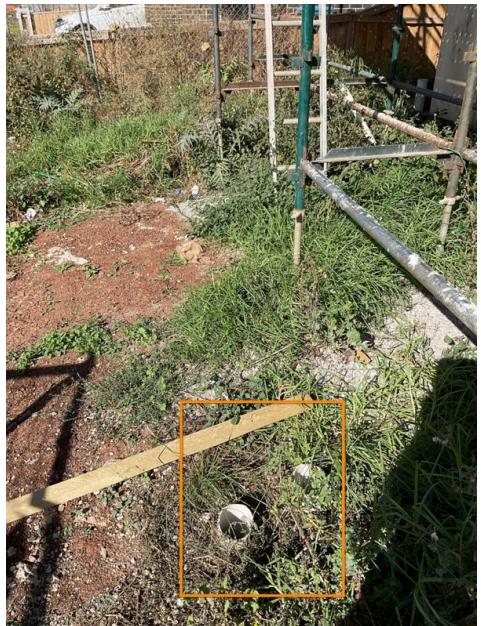
Front

Stormwater pipe(s) are not capped which can cause future water blockage by entered construction work materials and debris.

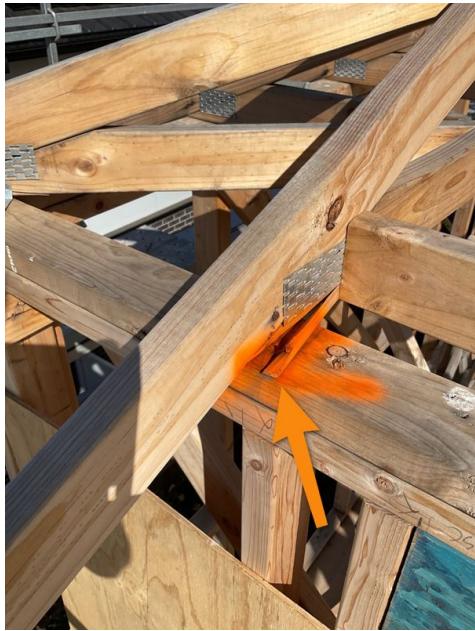
Front Left 1st Floor

**BROKEN TRUSS**
 Defects

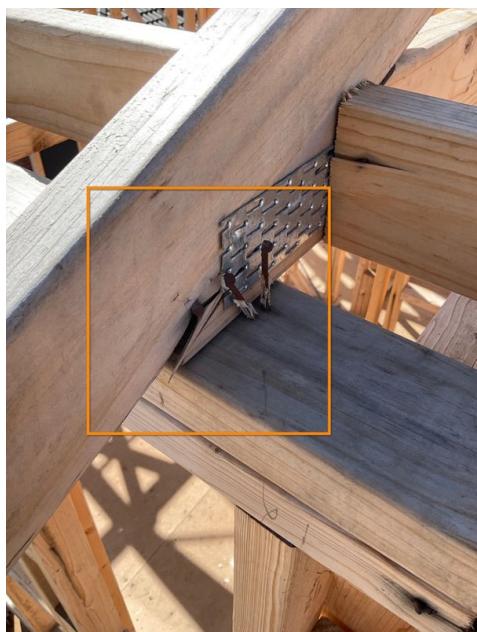
Rear 1st Floor

**2 NAILS REQUIRED ALL TRUSS TO PLATE CONNECTIONS.**

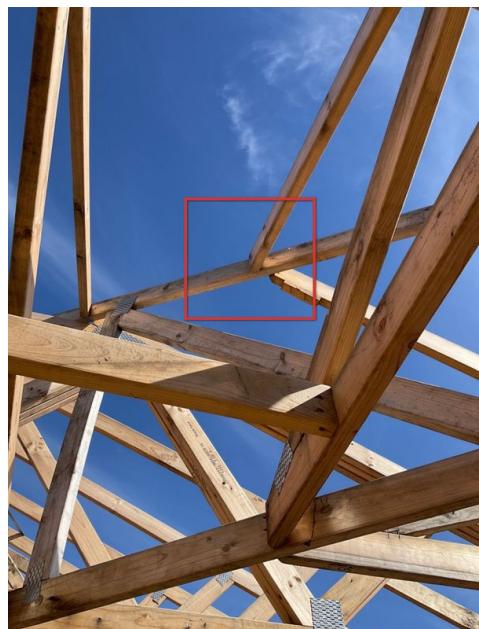
Front Right 1st Floor

## 2 X MITRE PLATES MISSING

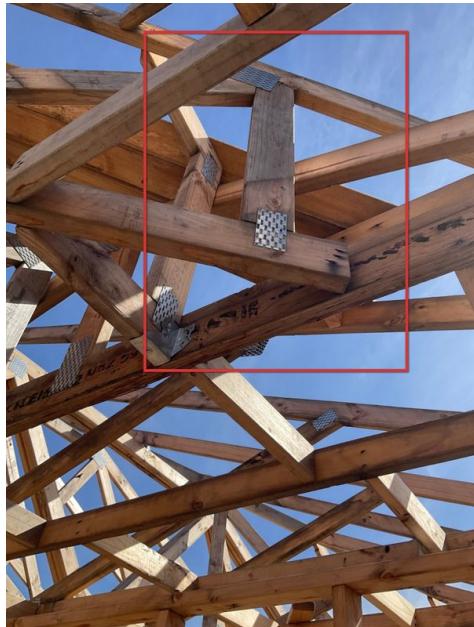
Front 1st Floor

## HIP SUPPORT BRACKET MISSING

Major Structural Defects/Safety Hazards

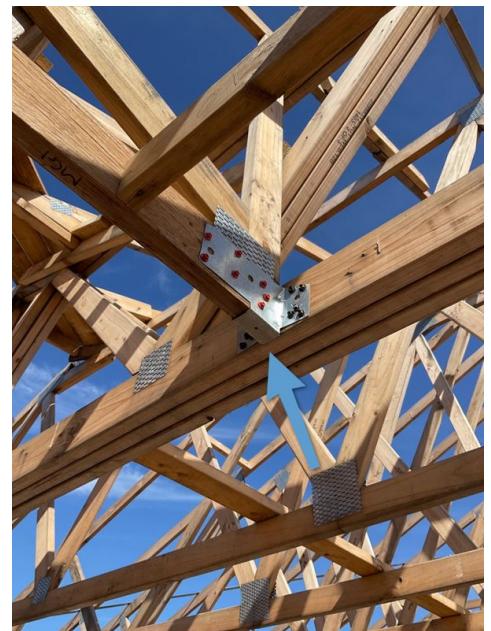
## + APPEAR FINE

Truss boots appear fine at time of inspection.

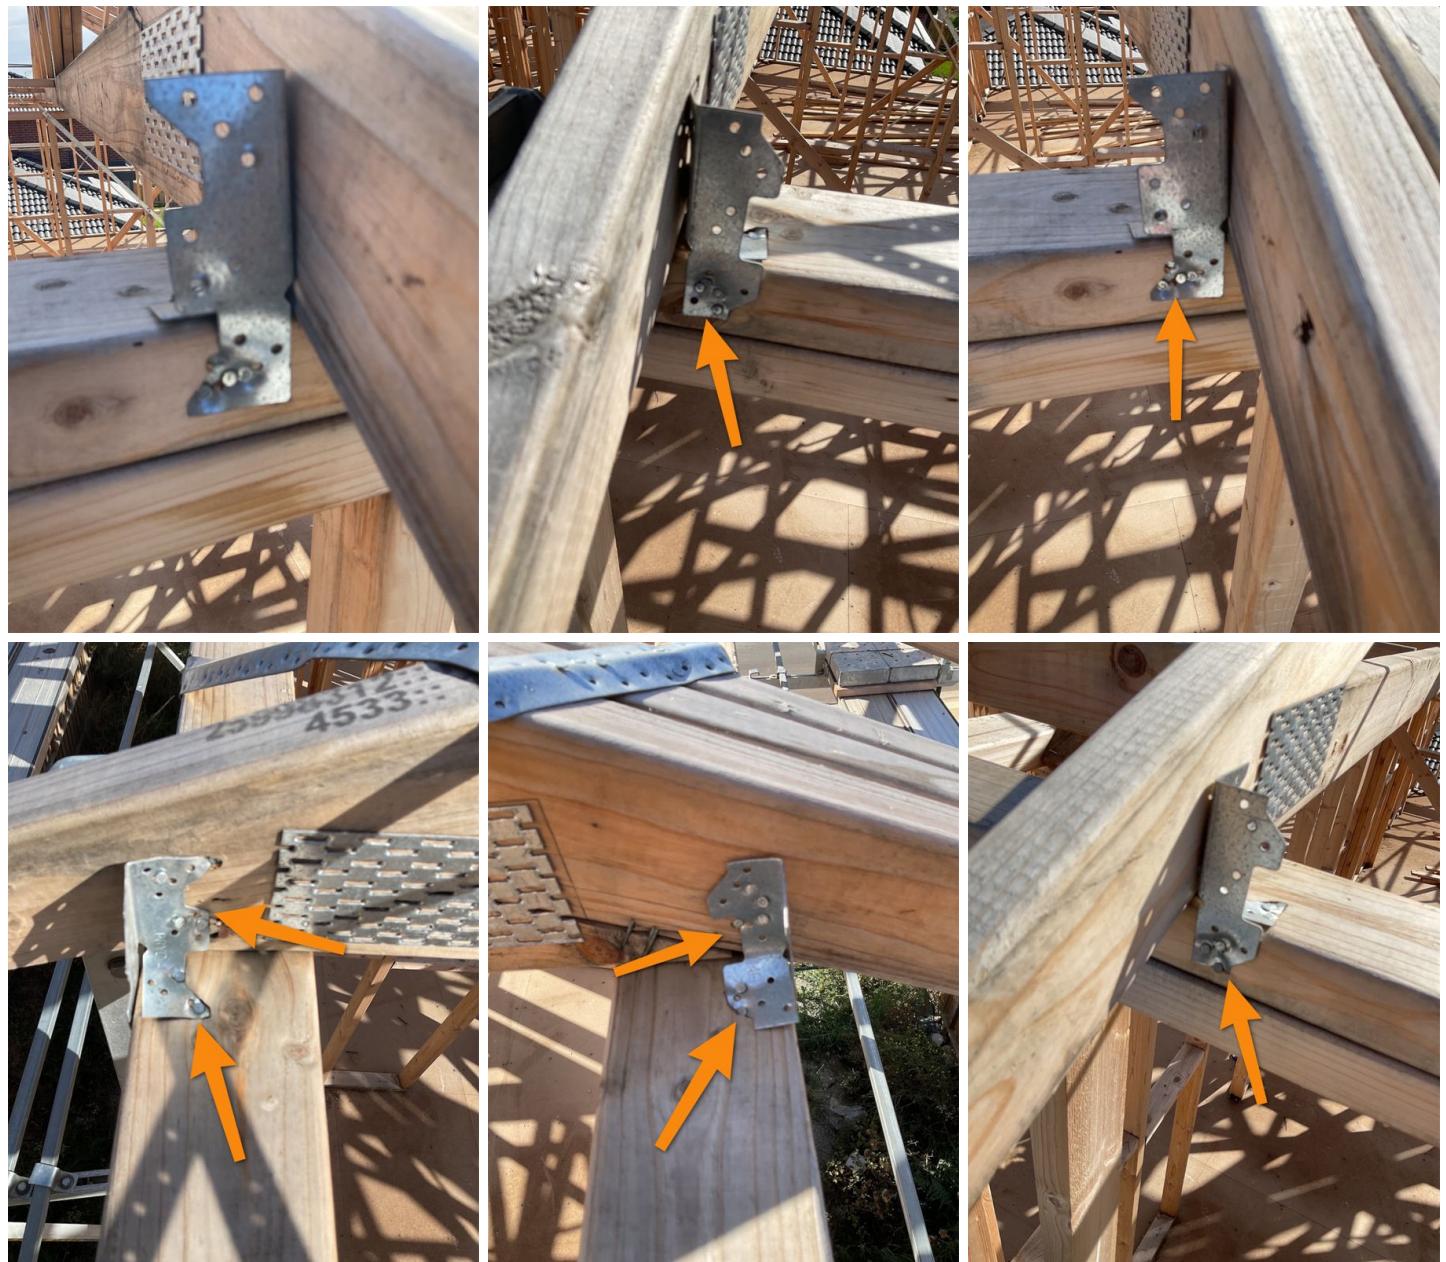
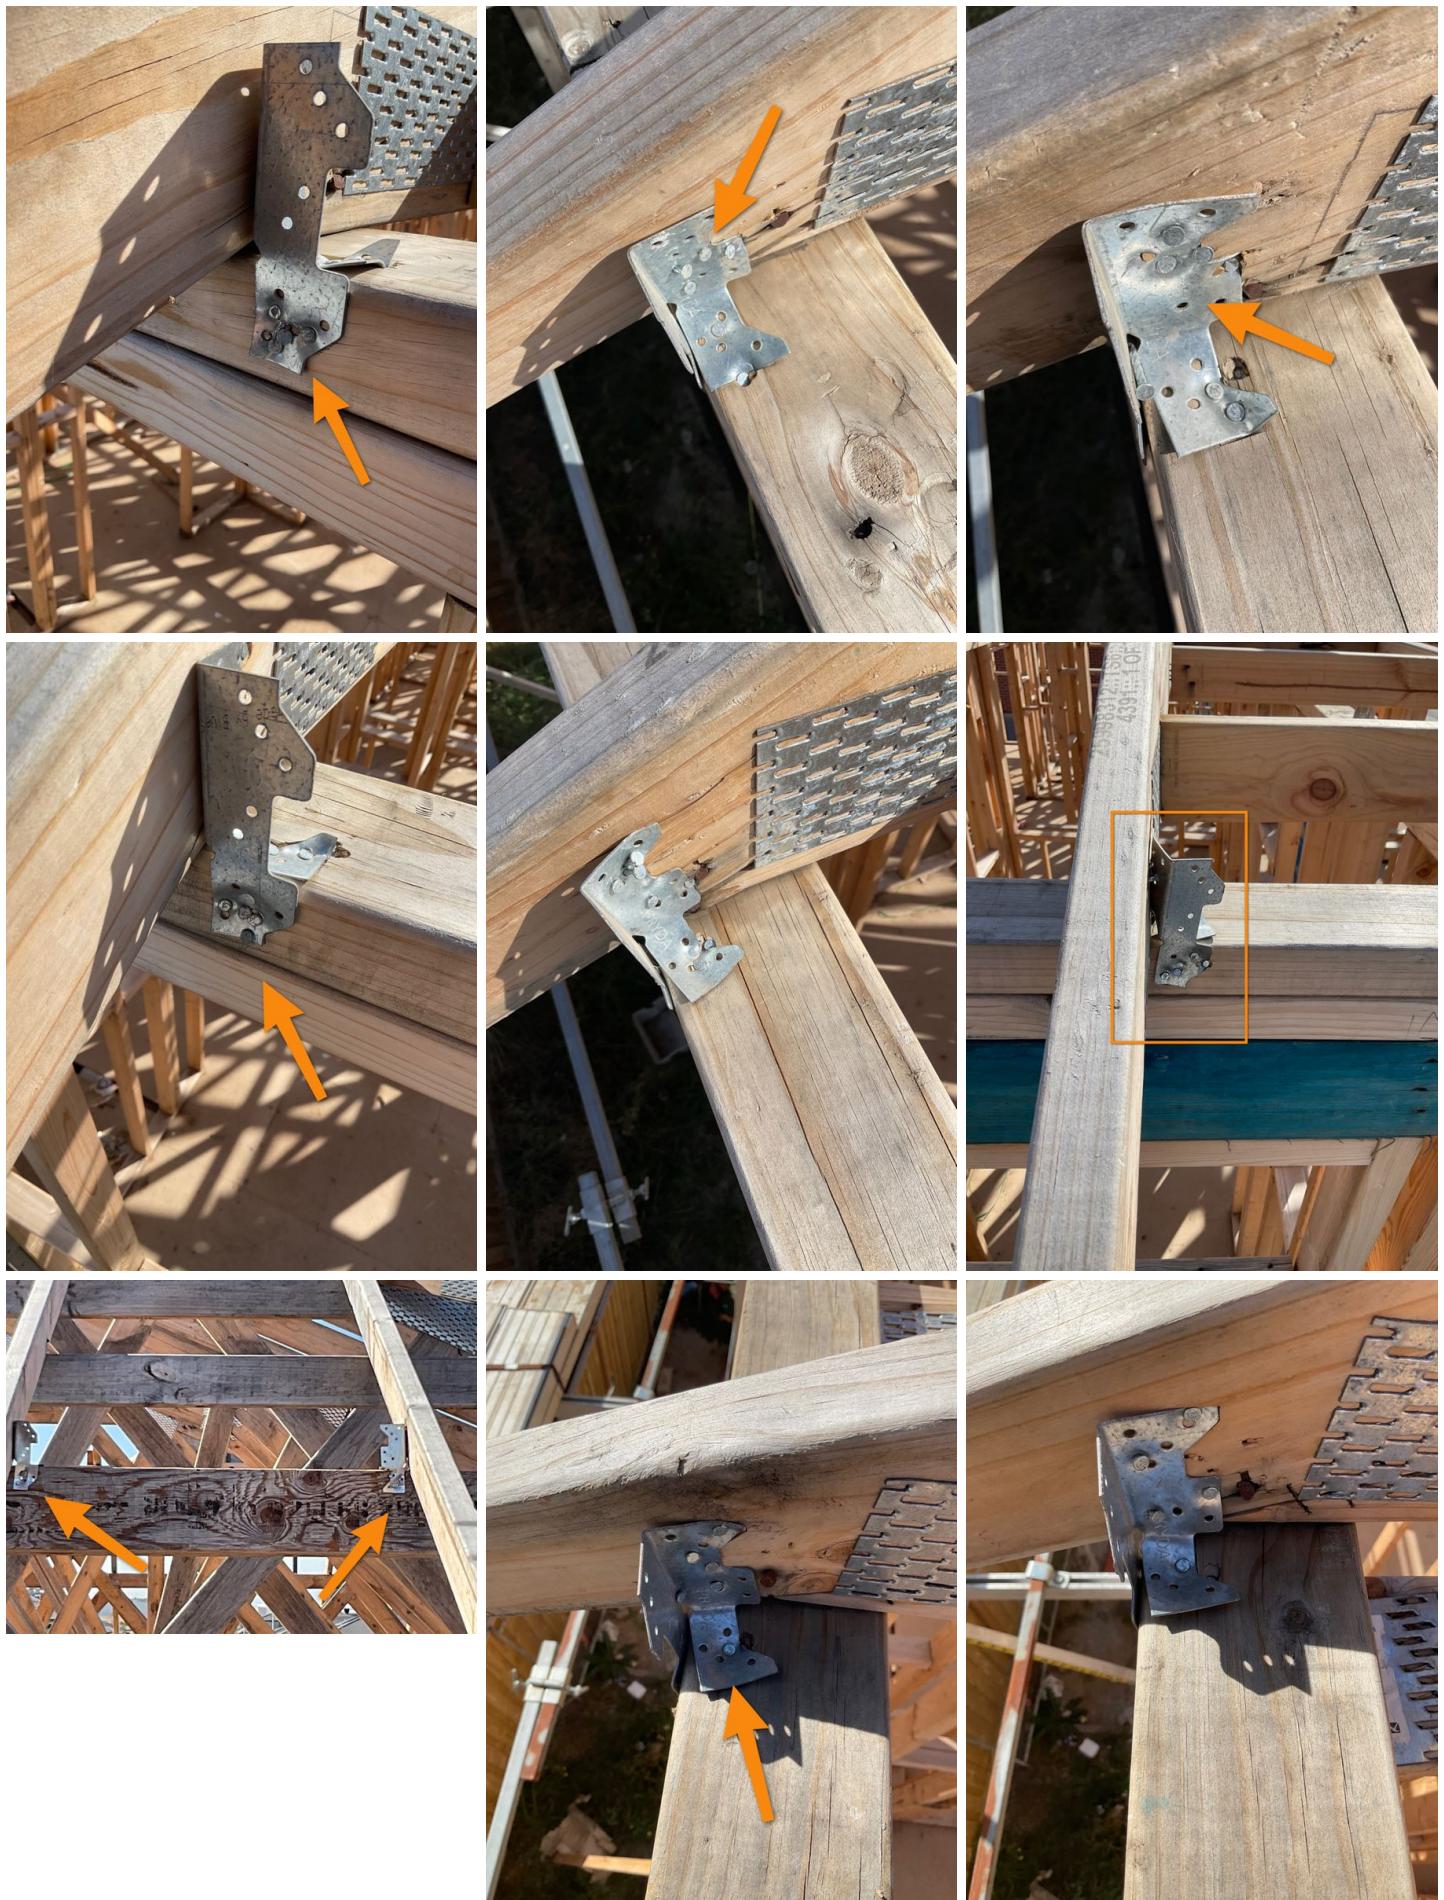
**+ IMPROPER FIXING**

Brackets installed, however have not been air nailed as per manufacturers pneumatic fixing requirements. Photos example only, most need to be replaced or rectified and nailed properly. Many nails also missing to brackets.

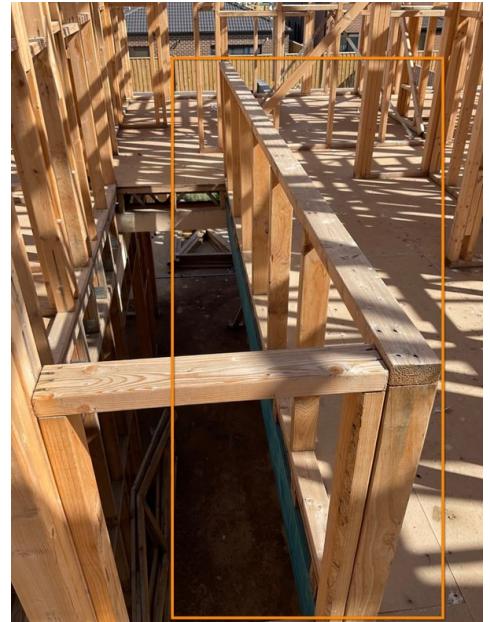
1st Floor

To be stiffened to prevent lateral force and damage.

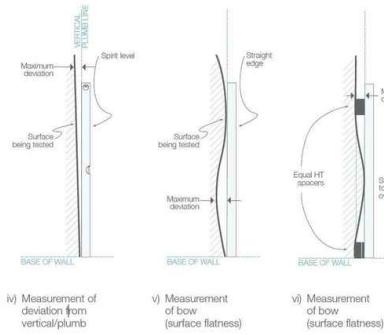
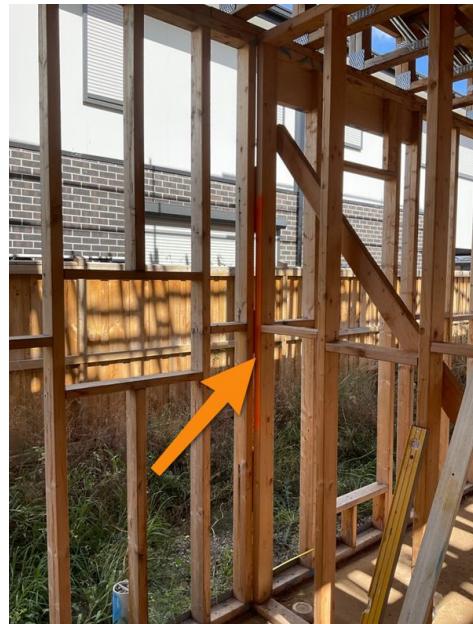
DIAGRAM E MEASUREMENT OF VERTICAL AND INCLINED SURFACES

Defects
**+ DEVIATE FROM VERTICAL - EXCEEDING THE TOLERANCE LIMIT**

Posts and wall frames are defective if they deviate from vertical by more than 5 mm over a 1.8 m height. (refer to diagram E).

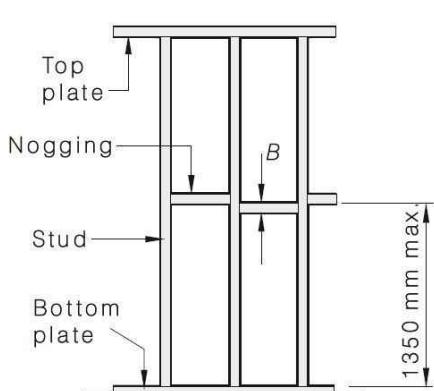
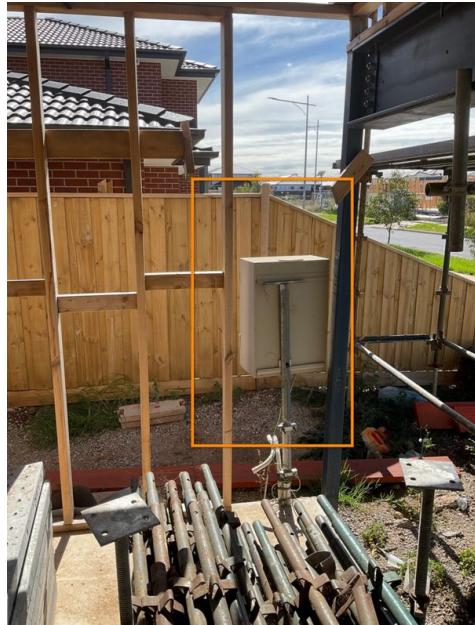
Defects
**+ ADDITIONAL NOGGING AROUND ELECTRICAL BOX**

The noggings spacing around the meterbox exceeds the maximum of 1,350mm. Additional nogging to be installed.

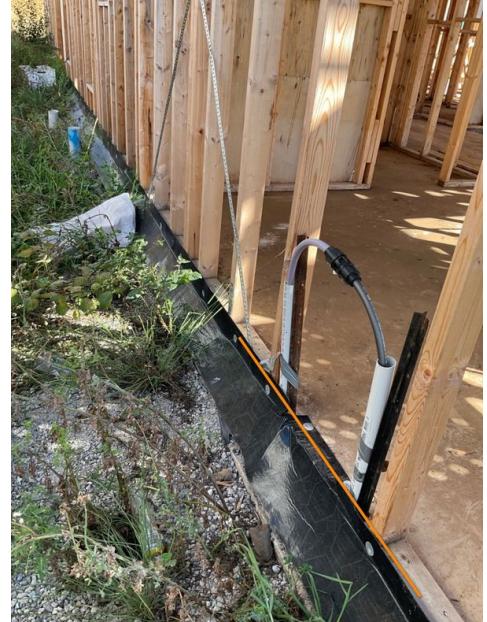
**AS1684.4 - 6.2.1.4**

Defects
**+ DISCONTINUOUS - LOADBEARING/BRACING WALLS**

Top and bottom plates in internal non-loadbearing and non-bracing walls may be discontinuous up to 60 mm (cut or drilled) to permit installation of services provided that, at the discontinuity, the plates are trimmed or otherwise reinforced either side of the discontinuity to maintain the lateral and longitudinal integrity of the wall.

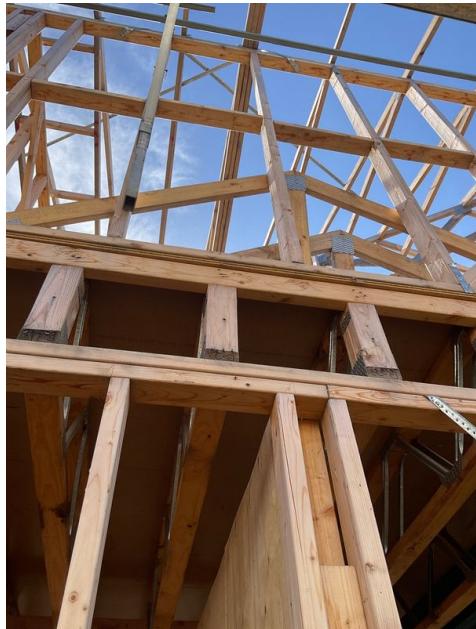
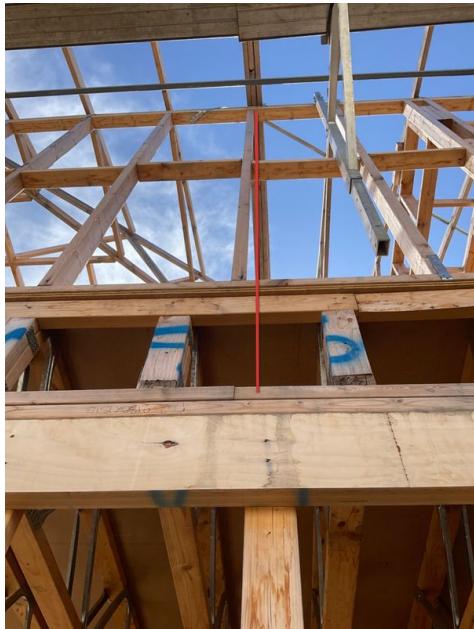
Left Rear

**+ BLOCKING UNDER CONCENTRATION OF LOAD**

Double stud (or triple stud if specified in engineering) must be installed under girder trusses to vertically transfer the concentration of load to the foundation.

Major Structural Defects/Safety Hazards

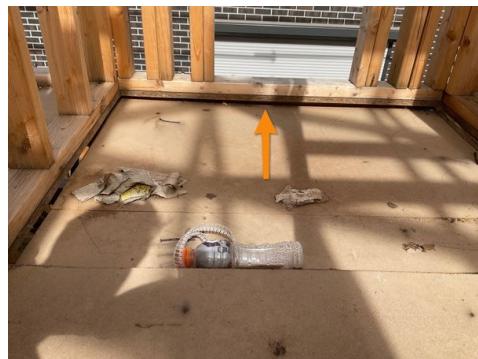
1st Floor

**SUPPORT REQUIRE SHOWER BASES VOIDS**

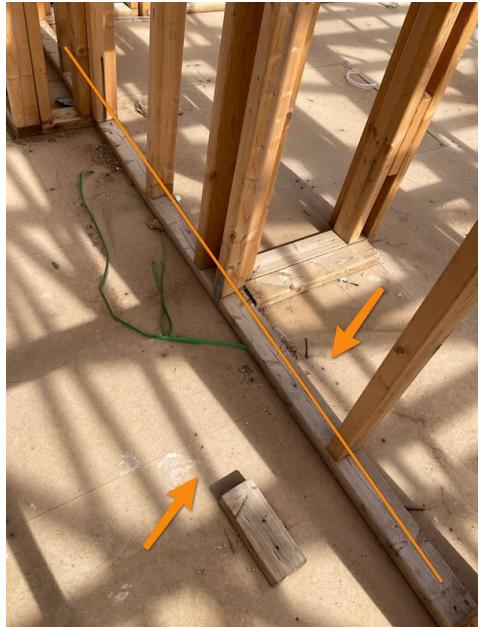
## POSI STRUT L BRACKETS AND BLOCKING NOT INSTALLED

All internal bracing and non bracing internal walls. Refer manufacturers guidelines. Parallel FF walls require blocking below also

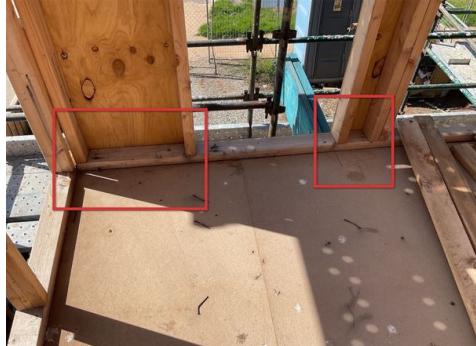
Front 1st Floor

**+ M10/12 TIE DOWN BOLT MISSING**

M10/12 tie down bolts are shown on Engineering drawings however one or more of them are missed and not installed. Bracing tie downs are playing a crucial role in the structural integrity and stability against the lateral forces. Rectification required ASAP and the proof to be provided to the client.

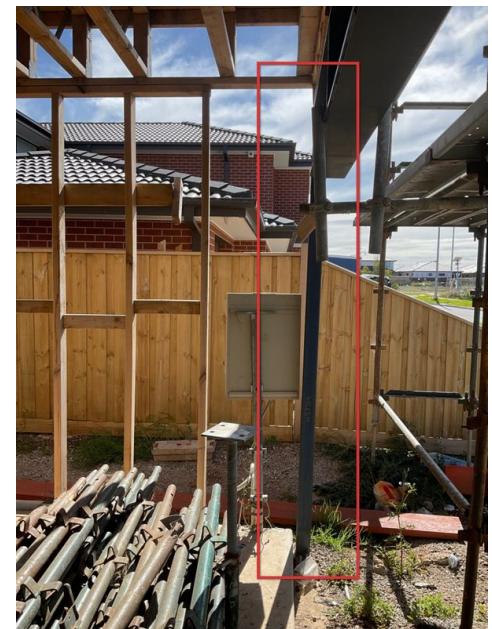
Garage Right

## COLUMN GROSSLY OUT OF PLUMB

Over 50mm

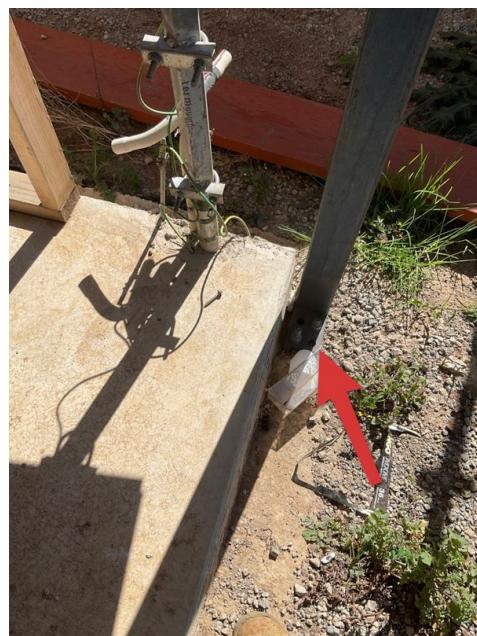
Garage Right

## COLUMN SITTING IN REBATE.

**⚠ Major Structural Defects/Safety Hazards**

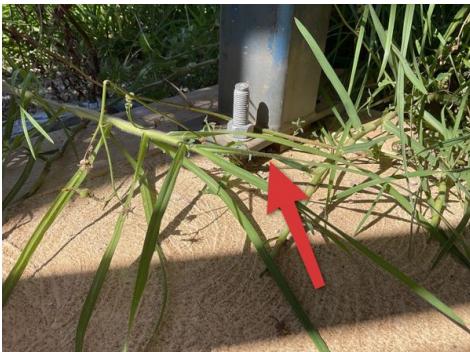
Porch

**GROUT REQUIRED TO COLUMNS.**

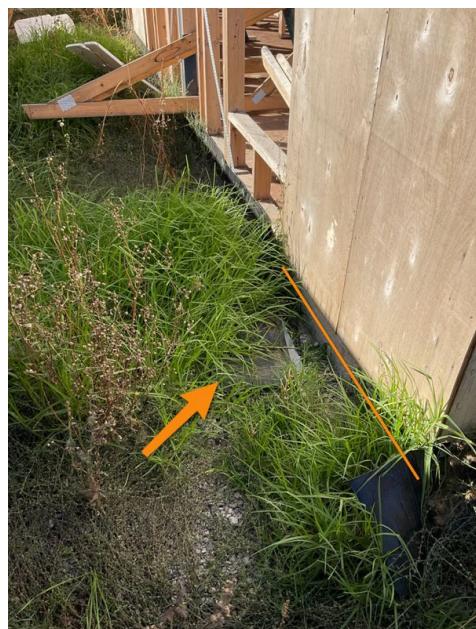
Right Rear

#### + LOOSE OR DAMAGES

Some parts of physical termite barrier aged or installed improperly. Fixing required.

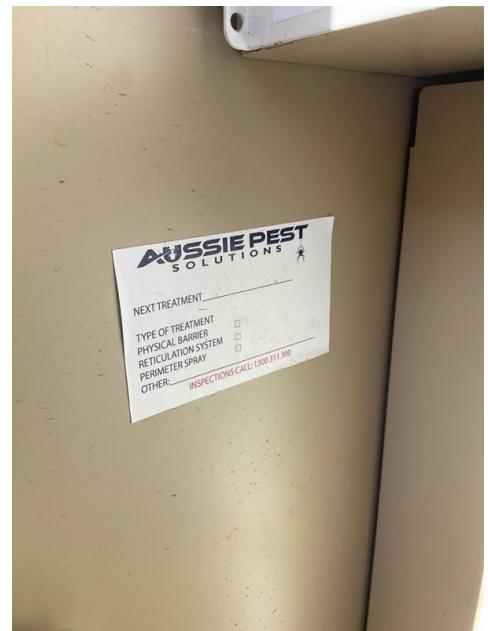
**+ FOUND**

Termite management notice is found but the writings cannot be read
