## LOCK-UP (PRE-PLASTER) INSPECTION REPORT

1234 Main St. Melbourne VIC 3000

Buyer Name  
05/08/2021 9:00AM

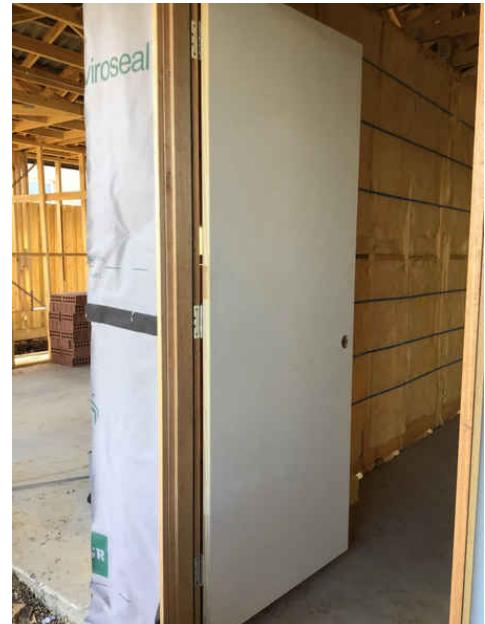
A temporary entry door installed. It is a usual practice to install a temporary door during the construction and replacing it by the permanent door in the later stages to avoid any damage during the construction.

Contact a qualified professional.

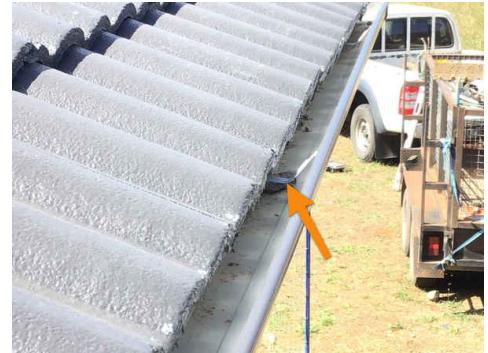
All debris to be removed from gutters as soon as possible to prevent them from entering the downpipes and causing water damage.

Contact a qualified professional.

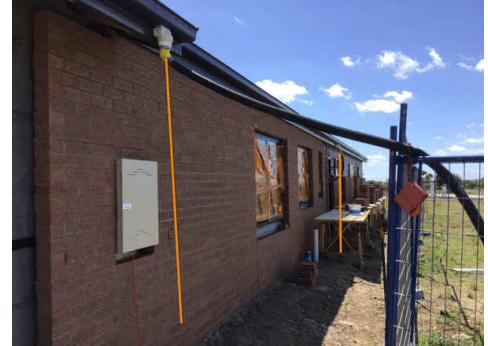
5.4.1 + Downpipes

one or more temporary downpipe(s) installed, however, they are not discharging to the stormwater system.

Temporary downpipes required to be installed properly during the construction phase to prevent the rainwater from ponding around the building and leaking under the slab.

Contact a qualified professional.

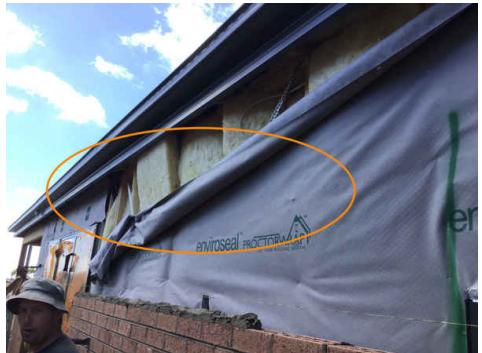
#### 6.4.1 Sarking **LOOSE SECTIONS**

One or more sections of sarking are not secured to the wall. This must be rectified prior to plastering/brickwork to ensure walls are watertight.

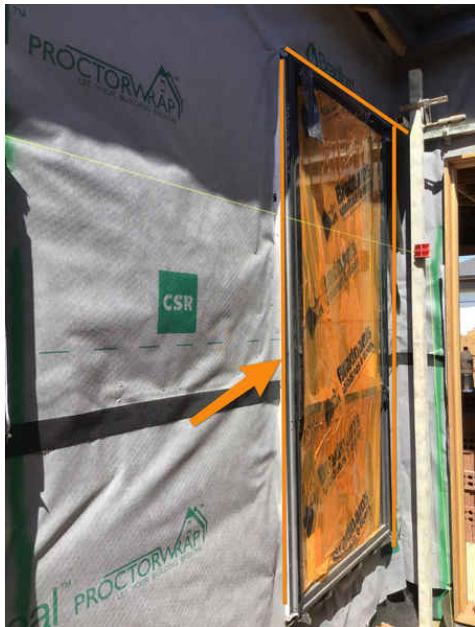
#### 6.4.2 Sarking **+ SEAL AROUND OPENINGS**

Sparking must be fixed around all windows, doors, metre box and other openings using proper sealing adhesive tape.

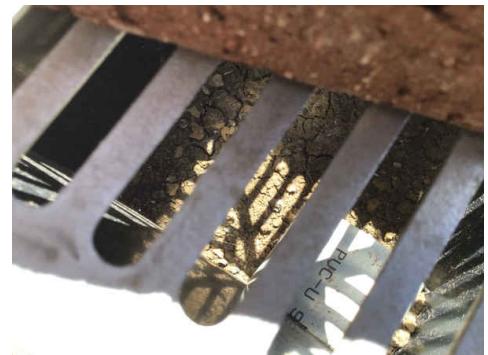
7.2.1 + Stormwater Drainage System (Underground)

Debris/soil noted in the silt pit(s) which can cause possible future stormwater system blockage. Builder to ensure the pits and the whole system is free of any external debris/soil. A camera inspection is recommended prior to handover to ensure the stormwater is not blocked.

Contact a qualified professional.

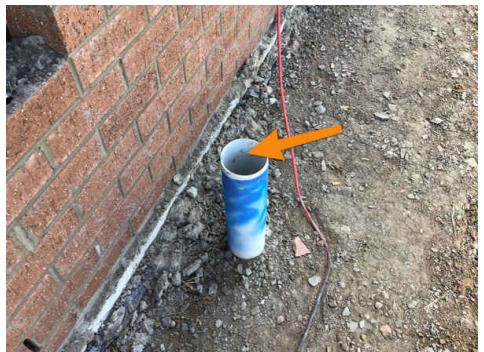
7.2.3 + Stormwater Drainage System  
(Underground)

### + UNCAPPED PIPE

Stormwater pipe(s) are not capped which can cause future water blockage by entered construction work materials and debris.

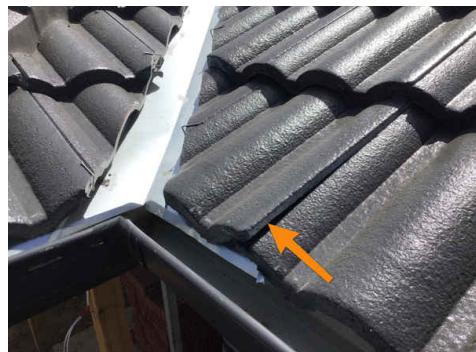
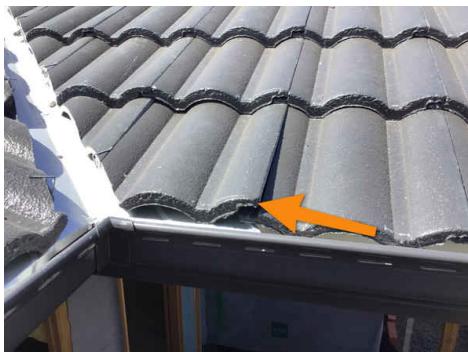
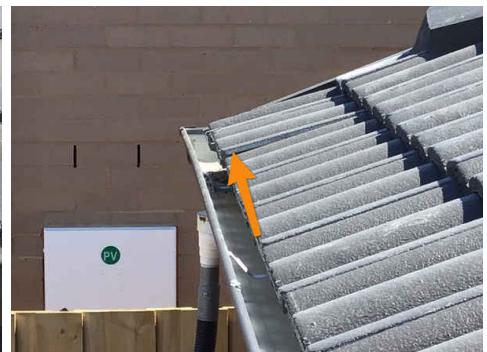
One or more roof tiles are not sitting in the correct position and need repositioning to prevent tile slippage and water leakage.

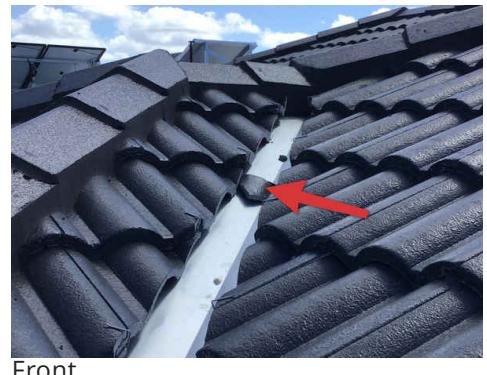
8.1.2 + Roof Cladding (Tile)

#### + BROKEN/CRACKED ROOF TILES

One or more roof tiles are broken or cracked and need replacement to prevent the property from water damage.

Major Structural Defect/Safety Hazard

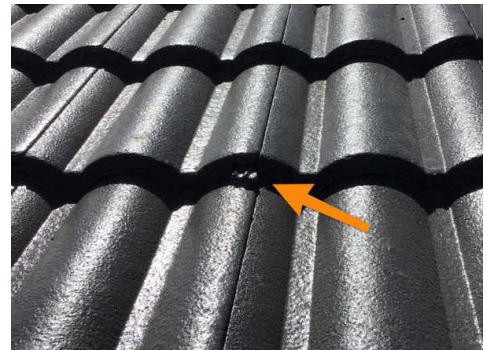
## 8.1.3 + Roof Cladding (Tile)

**+ BROKEN TILE UNDERLAP**

One or more roof tiles underlap are broken. Such tiles must be replaced to ensure the building will remain watertight during heavy rains and storms.

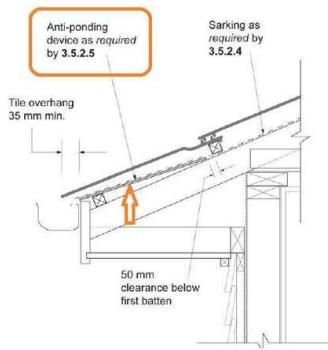
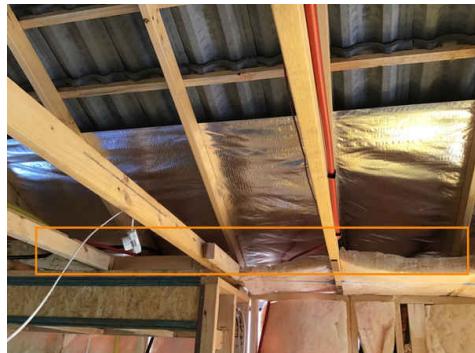
## 9.3.1 + Sarking &amp; Anti Ponding

**+ ANTI-PONDING BOARD REQUIRED - (WHEN SARKING INSTALLED UNDER TILED ROOF)**
- Repair recommended

Figure 3.5.2.4 Typical installation of anti-ponding device/board

Contact a qualified professional.

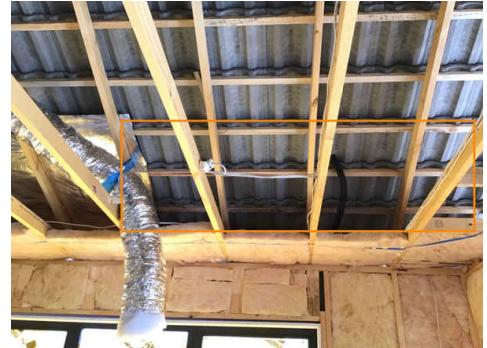
## 9.3.2 + Sarking &amp; Anti Ponding

**+ INCOMPLETE**
- Repair recommended

Contact a qualified professional.

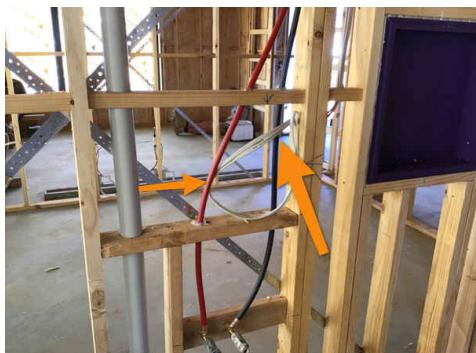
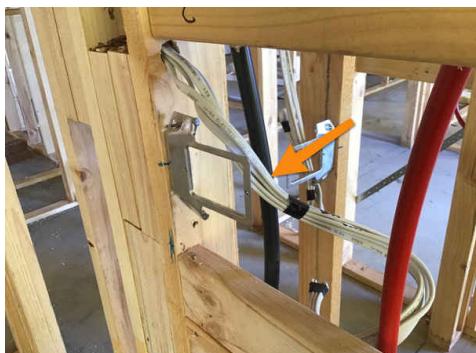
## 10.4.1 Electrical

**CABLES IN CONTACT WITH PLUMBING PIPES**

Repair recommended

Contact a qualified professional.

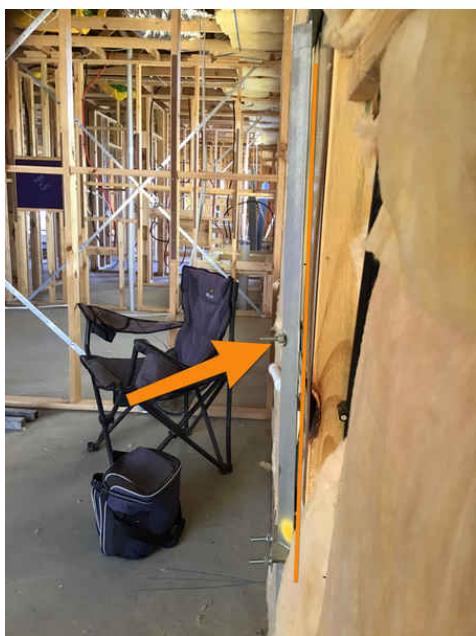
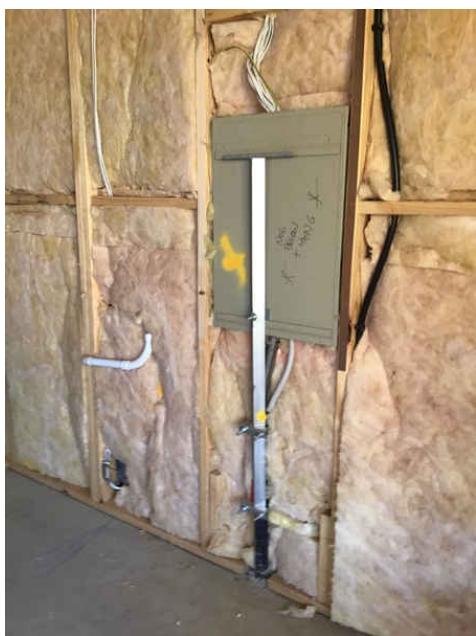
## 10.4.2 Electrical

Repair recommended

Contact a qualified professional.

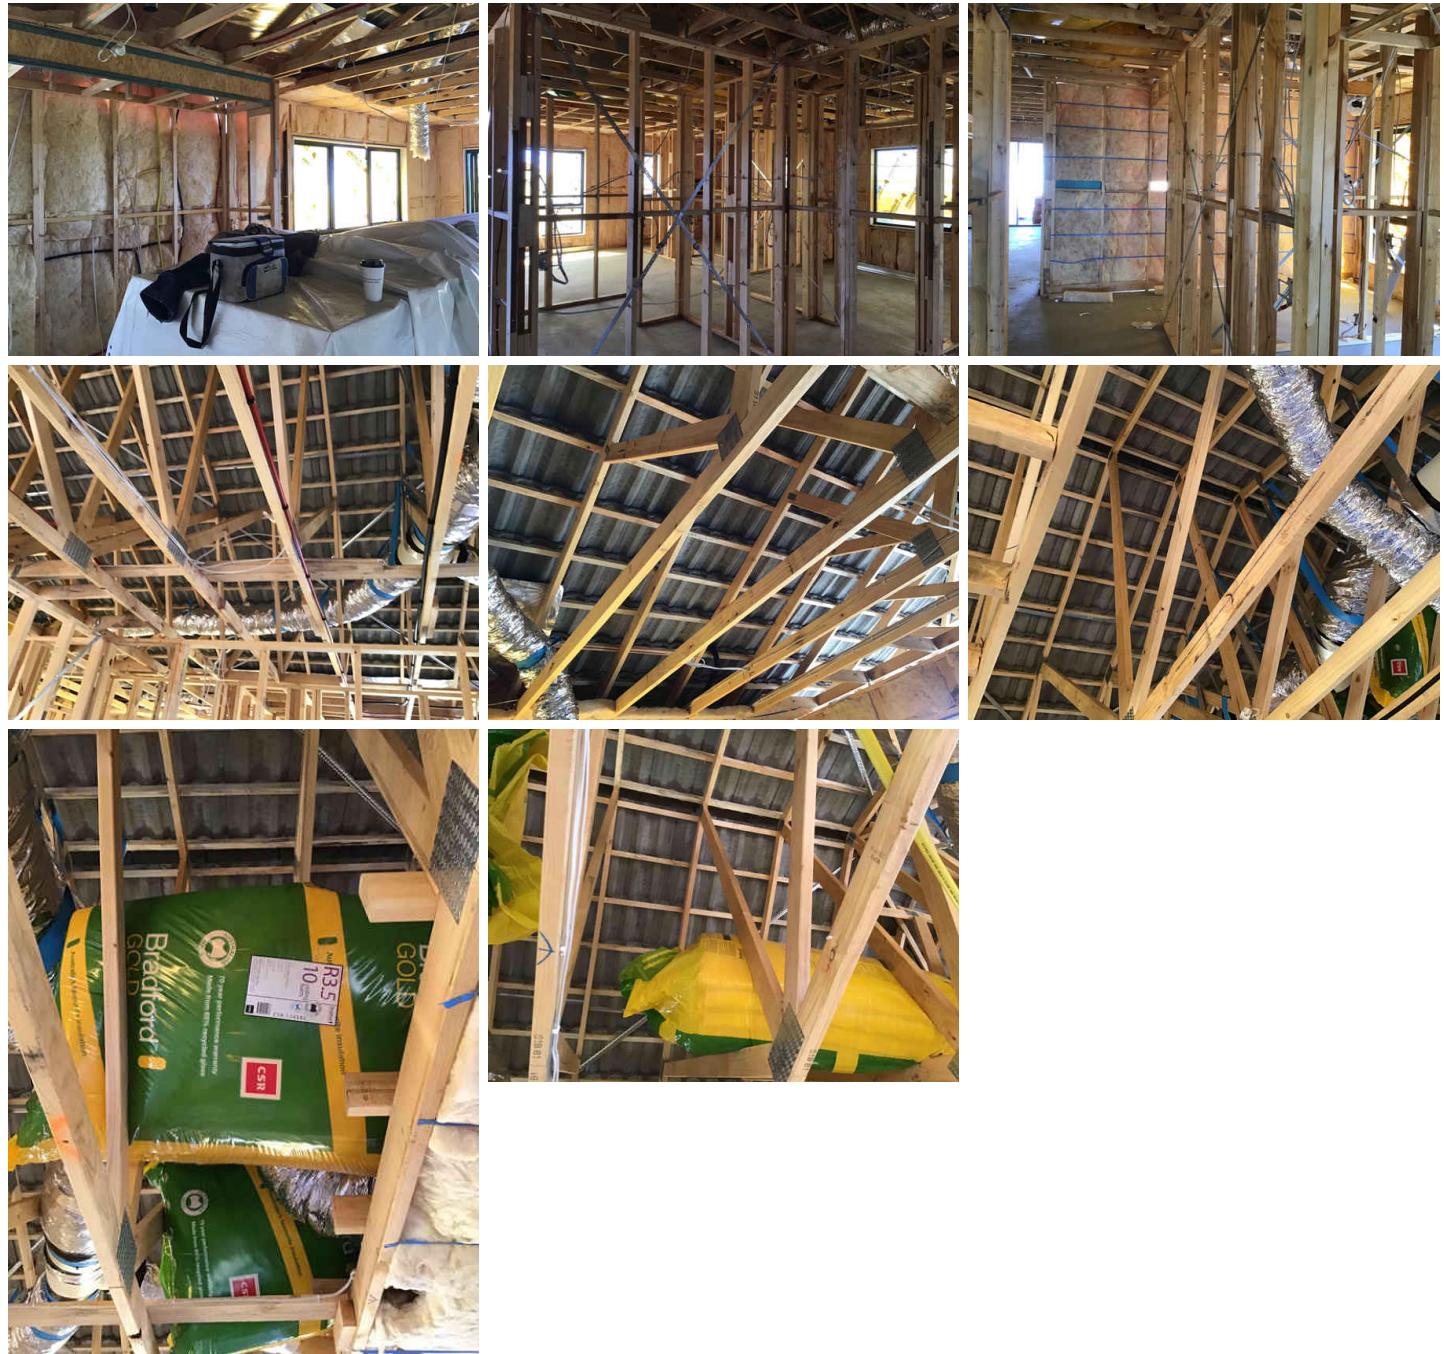
## 10.5.1 Insulation

**NOT INSTALLED - CEILING INSULATION**

Contact a qualified professional.
